Manhole Inspection Summary

Manhole # S08II2002MH

Location Address: **7310 Park Village Ct** Cross Street: **Park Heights Ave**

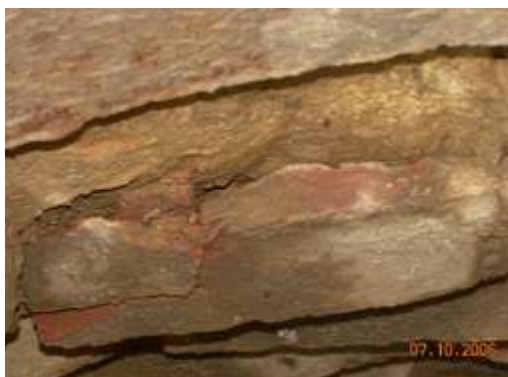
Defect

Chimney / Frame Adjustment ☒ Exists Material: **Brick** ☐ Parged Height: **3** (in.)
Condition: ☐ Sound ☐ Cracked ☐ Root Intrusion ☒ **Loose Brick** ☐ Deteriorated
Infiltration: ☐ None ☒ **Joint** ☐ Cracks ☐ Mortar ☐ Roots ☐ Wall

Adjustment loose bricks and infiltration

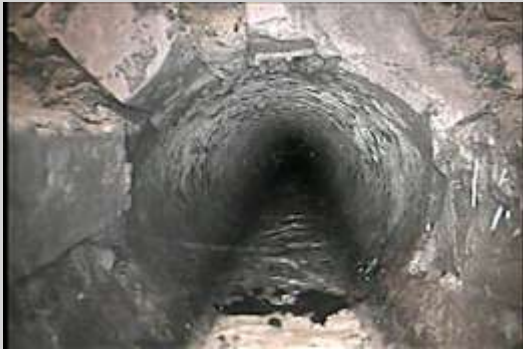
8 in. Circular Gravity Sewer Pipe Out @ 12 O'Clock

Deposits: ☐ None ☐ Mud ☐ Sludge ☒ **Debris** ☐ Grease

Silt Depth: **0.5** (in.) Deposits Extent: **Light**

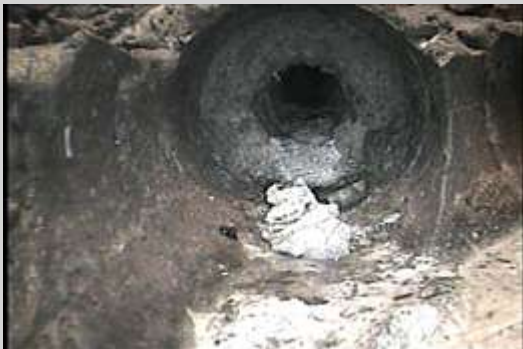
8 in. Circular Gravity Sewer Pipe In @ 6 O'Clock

Deposits: ☐ None ☐ Mud ☐ Sludge ☒ **Debris** ☐ Grease

Silt Depth: **0.5** (in.) Deposits Extent: **Light**

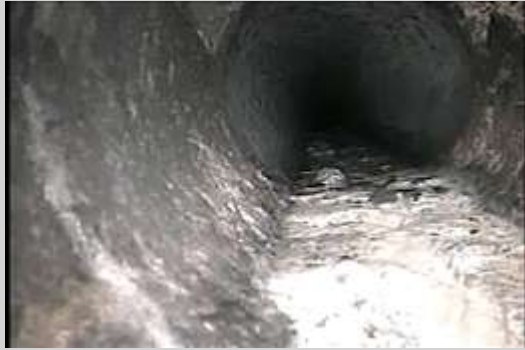
Pipe In @ 7 O'Clock

Deposits: ☐ None ☐ Mud ☐ Sludge ☒ **Debris** ☐ Grease

Silt Depth: **0.5** (in.)

Deposits Extent: **Light**
